# Degradation effects on structural safety of masonry walls

Ph.D. Thesis presented  
for the fulfillment of the Degree of Doctor of Philosophy  
in Ingegneria Strutturale, Geotecnica e Rischio Sismico

The author's work has been carried out in the framework of the PRIN 2017 (Progetti di Rilevante Interesse Nazionale) DETECT-AGING “*Degradation Effects on sTructural safEty of Cultural heriTAGE constructions through simulation and health monitorING*” (Grant No. 201747Y73L).

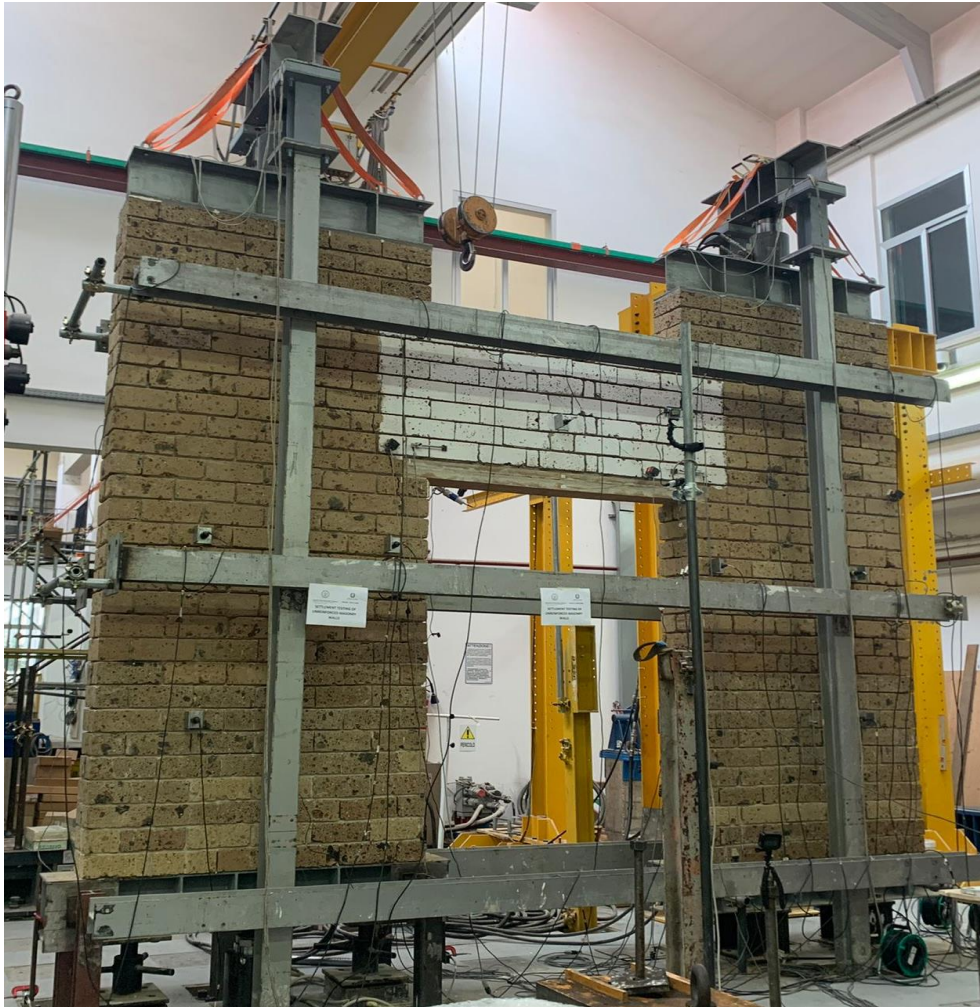
**Figure 42. Experimental setup of deteriorated URM under settlement load**

So, according to the adopted assumptions, wall failure is attained as the decreasing support reaction becomes stable or resumes its initial value so that increments in displacement do not produce load change at the fixed support.

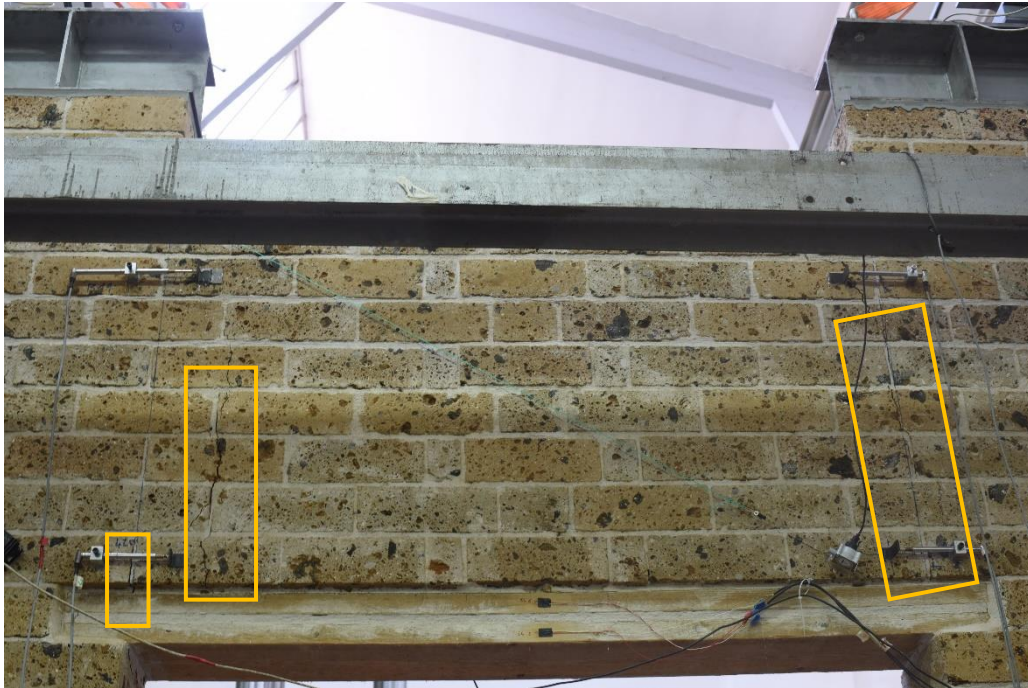
**Figure 43. Crack pattern at 15mm of settlement applied to intact URM, frontal side**

Figure 43 and Figure 44 show the damage pattern observed after the settlement test on the intact URM, with vertical cracks owing to flexure occurred at the end sections of the spandrel panel. The initial cracks grow and propagate on each side of the spandrel panel. It is noted that cracks are small at one end and wider at the other, often seen both on the inside and outside the building.

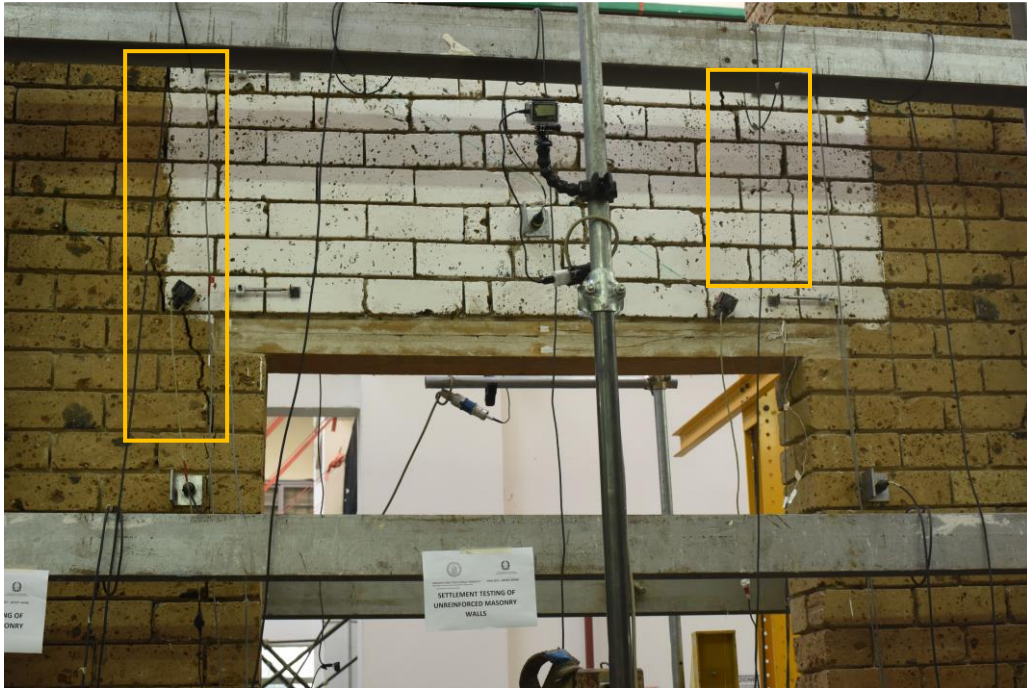
**Figure 45. Crack pattern at 35mm of settlement applied to deteriorated URM, frontal side**

Wooden lintel supported the masonry above and constrained the spandrel panel in transmitting the applied load between the piers

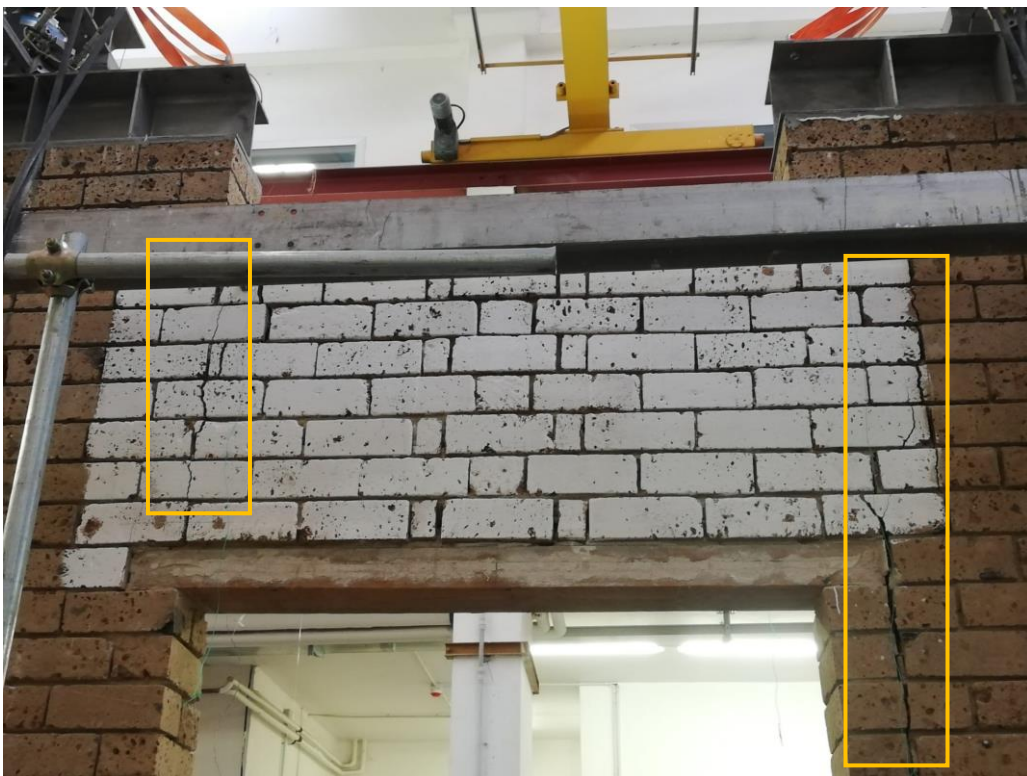
**Figure 46. Crack pattern at 35mm of settlement applied to deteriorated URM, back side**

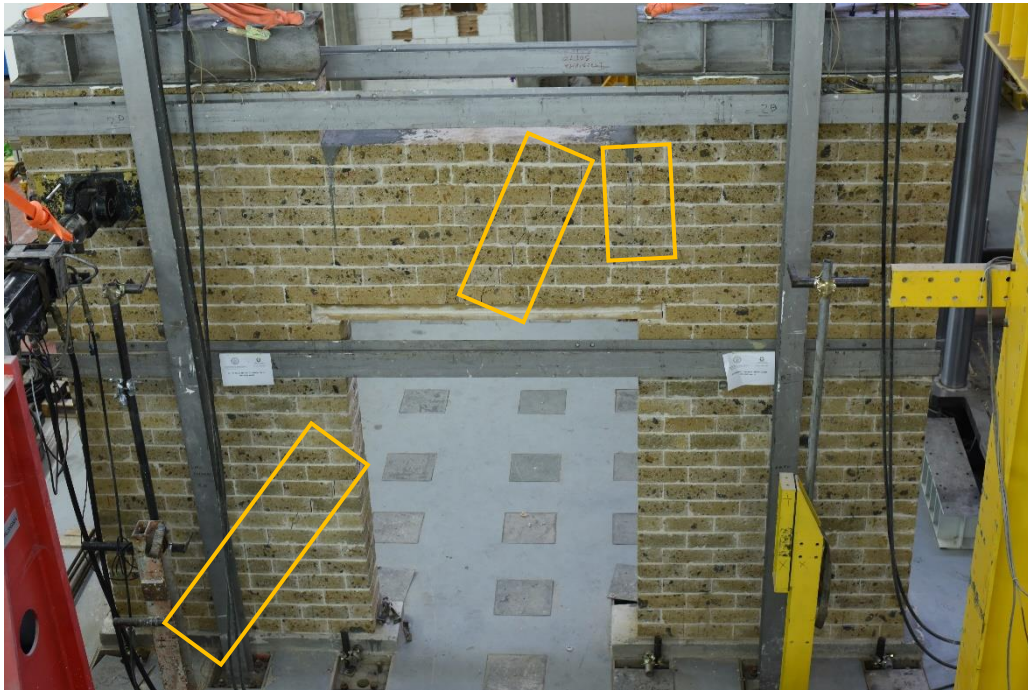
**Figure 54. Crack pattern for intact URM, frontal side**

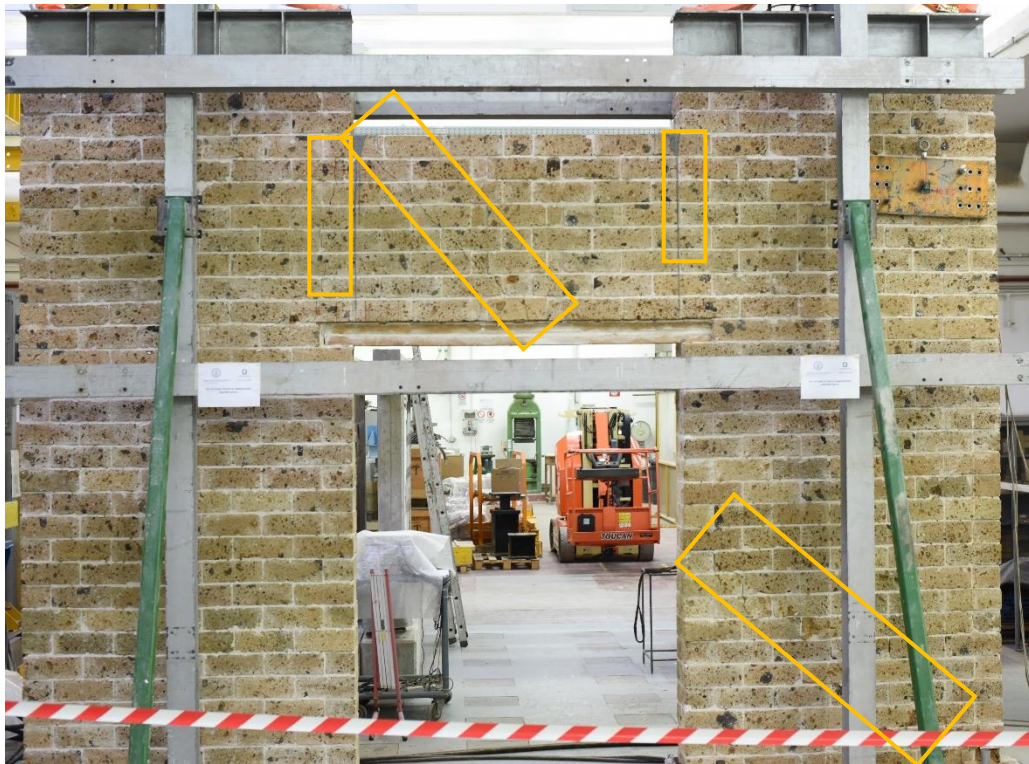
**Figure 55. Crack pattern for intact URM, back side**

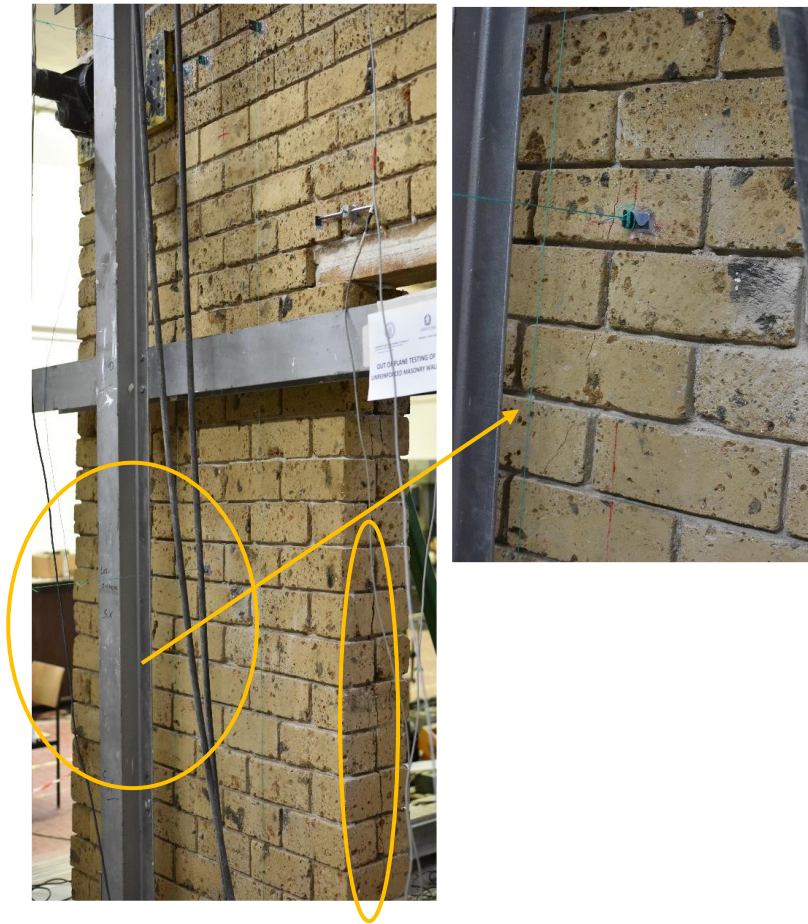
**Figure 65. Crack pattern of loaded pier with details, deteriorated URM, frontal side.**
